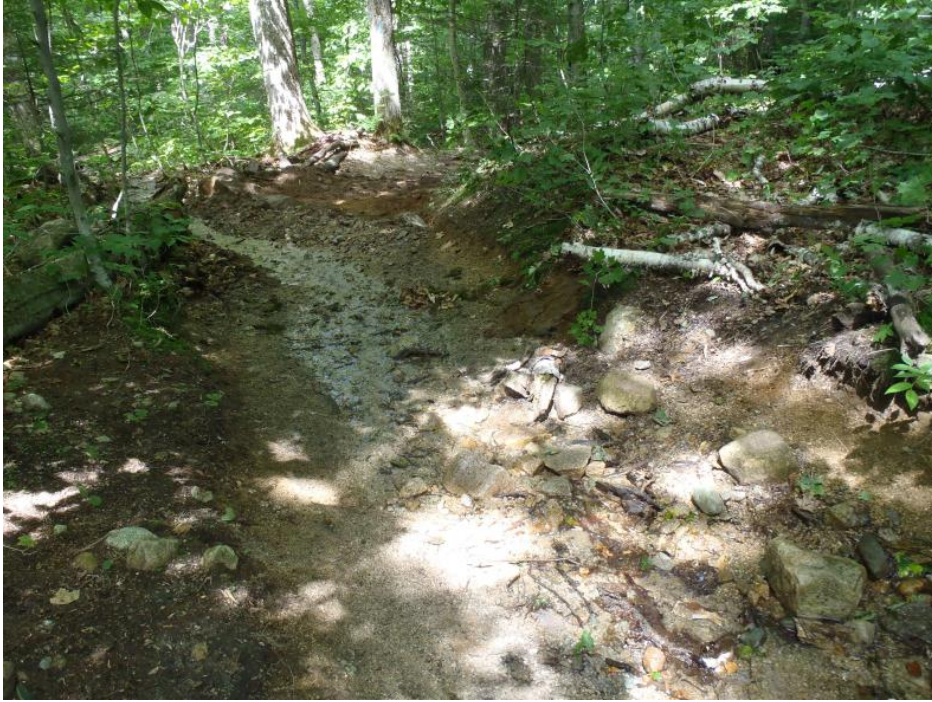
Erosion created by Tropical Storm Irene

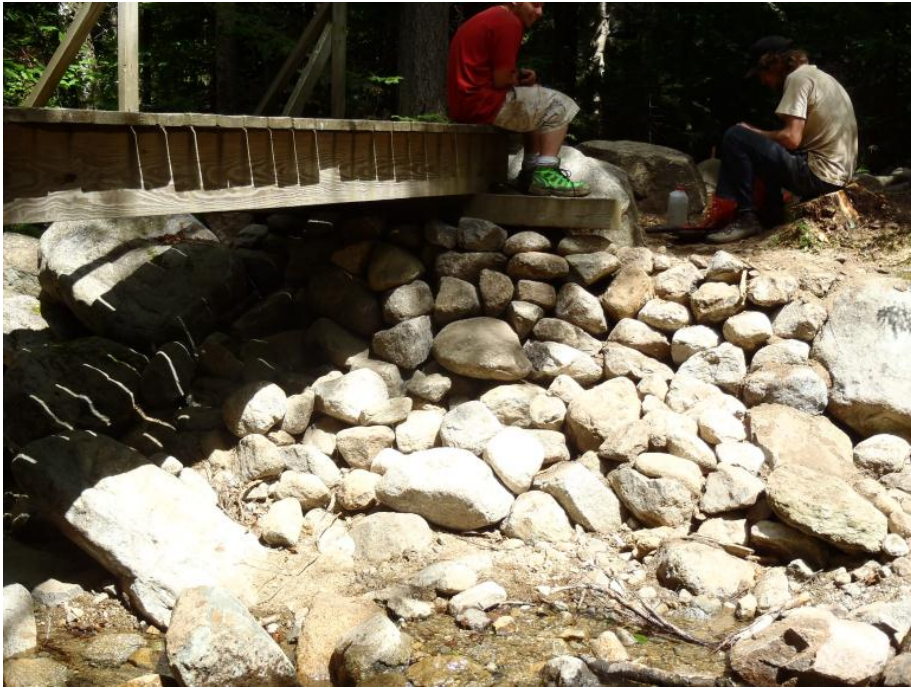
This bridge abutment also needed reconstruction after Tropical Storm Irene.
